"Full" Reserve Study

Bordeaux HOA Everett, WA

Report #: 33557-0
For Period Beginning: January 1, 2018
Expires: December 31, 2018

Date Prepared: February 27, 2018

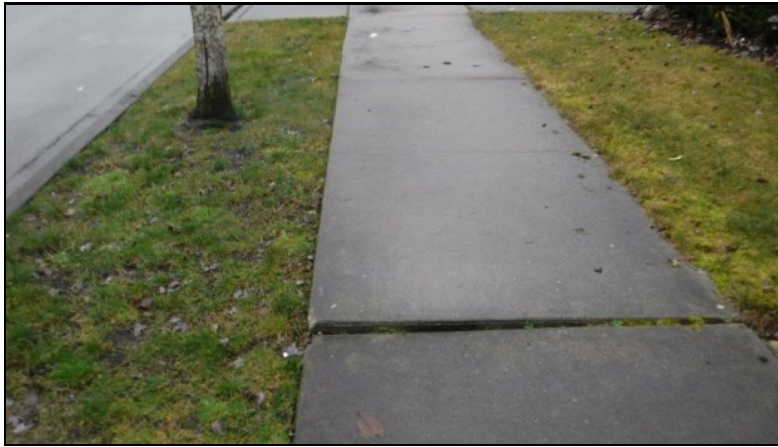
Comp #: 100 Concrete - Repair/Replace

Evaluation: Some sidewalk lifting noted which appears to be due to street trees in adjacent planter strips. As discussed with city of Everett, sidewalks adjacent to streets are the adjacent lot owner responsibility for maintenance, repair and replacement. However, according to city, owners can request city do work at sidewalks and owner would only be responsible for cost of materials. However, there is a long list for this work and Everett website indicates it could be as long as 8 years before work gets completed. See <https://everettwa.gov/886/Sidewalks>.

We are aware that the Association is maintaining the planter strips, including street trees, immediately adjacent to the streets. The Association may consider work needed at sidewalks caused by street trees to be Association responsibility as well. Association should discuss this with attorney and make definitive decision and make clear to community. At this point no reserve funding included.

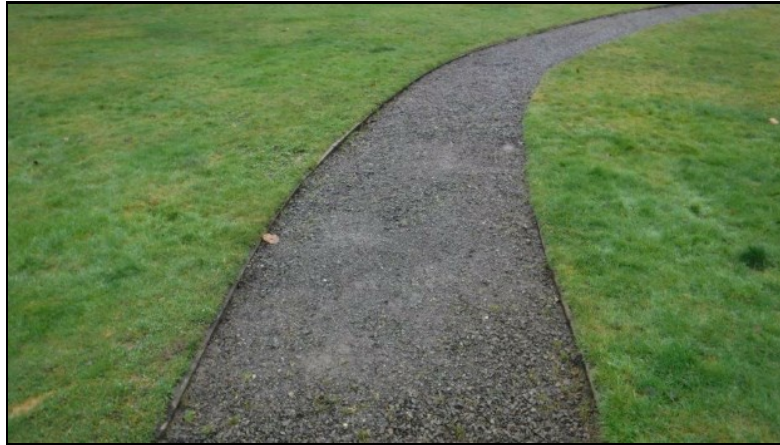
Evaluation: Generally adequate coverage of gravel with no major depressions observed. With small total area, we assume ongoing refurbishing/replenishment should be part of annual maintenance program with no predictable basis for reserve funding.

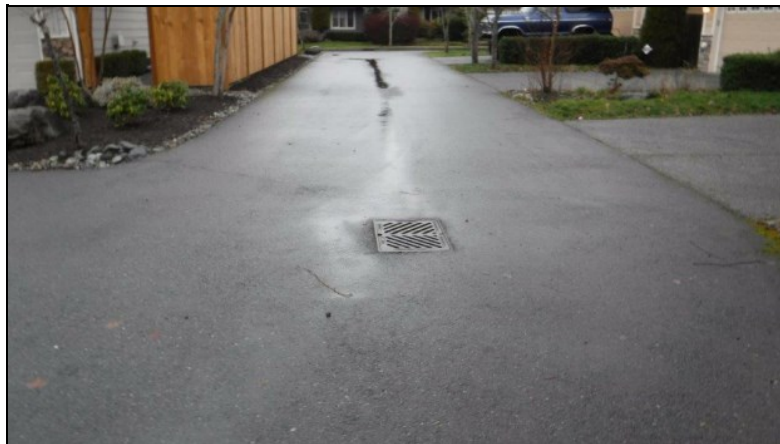
Evaluation: No major damage noted, however a couple local cracks; one at corner intersection and another most likely caused by underlying roots. Reportedly a repair in the past due to sink hole and speed bump installed 2010, but no other work to asphalt known since installed.

Useful life below assumes regular seal coating and repairs (see component #121). The lack of seal coating and repairs can greatly decrease the asphalt's useful life. Resurfacing is typically one of the larger expense items in a reserve study. When need to resurface is apparent within a couple of years, consult with geotechnical engineer for recommendations, specifications / scope of work and project oversight.

As routine maintenance, keep surfaces clean and free of debris, ensure that drains are free flowing, repair cracks, and clean oil stains promptly. Assuming proactive maintenance, plan to resurface at roughly the time frame below.

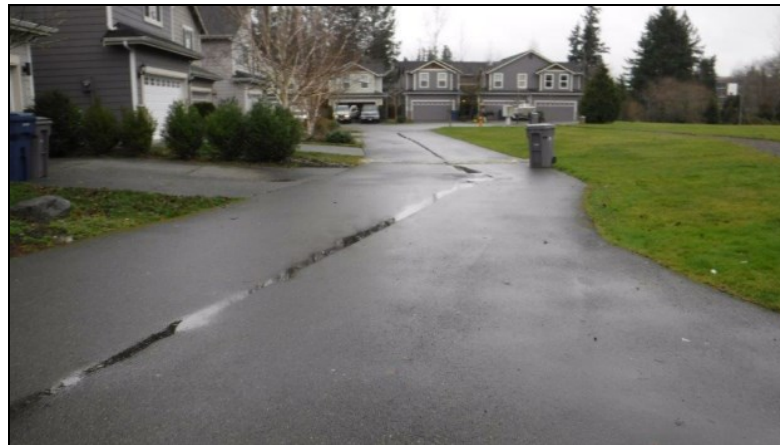
Evaluation: Reportedly a repair due to sink hole in the past. No history of sealcoating, so no surface seal. The majority is in stable condition, however a couple spots where cracking has occurred at corner intersection and another where underlying tree roots are causing uplifting/damage.

Regular cycles of seal coating, along with needed repairs is a best practice for the long term care of lower traffic asphalt areas to extend the useful life. We recommend starting routine clean/sealcoat cycles as shown here.

Repairing asphalt before seal coating is imperative. Thorough surface preparation and dry weather during and following application, is key to lasting performance. The ideal conditions are when the air and surface temperatures are 50 degrees and rising, with low humidity and calm wind. Seal coating should never be done when showers are threatening. Incorporate any striping and curb repair into this project. Fill cracks with hot rubberized crack fill and clean oil stains promptly in between cycles as routine maintenance.

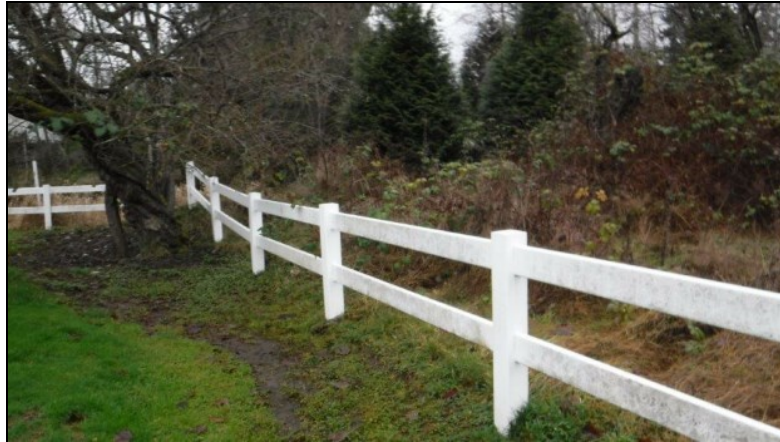
Comp #: 140 Vinyl Fence - Replace

Evaluation: Double rail, vinyl fencing has dirt/grime, but no obvious instability observed. Reported to us post caps were vandalized/removed at one point and Association has not replaced.

Plan to replace at roughly the time frame below. As routine maintenance, clean fencing and inspect regularly for any damage and repair as needed. If cleaning is not completed, can accelerate replacement of fencing due to contaminants on surface.

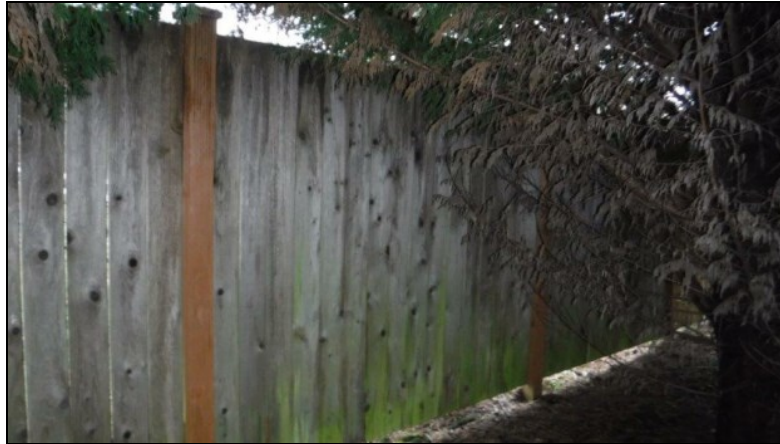
Comp #: 142 Wood Fence - Repair/Replace

Evaluation: As discussed with our board contact, possibility that a portion of this fencing was existing prior to development of this site and remaining area built during construction of this community. Appearance of wood is weathered/faded in areas as no routine cleaning/staining as comprehensive project.

Plan to replace at roughly the time frame below. Typical failures occur from deterioration through end grains, contact with ground and surrounding landscape. Although portion of fencing may not be owned by Bordeaux, in the interest of keeping this Association perimeter consistent, funding for replacement of entire fence line included here.
